DAMAGE PROFILES IN SILICON AND THEIR IMPACT ON
DEVICE RELIABILITY

G. H. Schwuttke

International Business Machines Corporation

TECHNICAL REPORT No. 7, Part I
January 1976

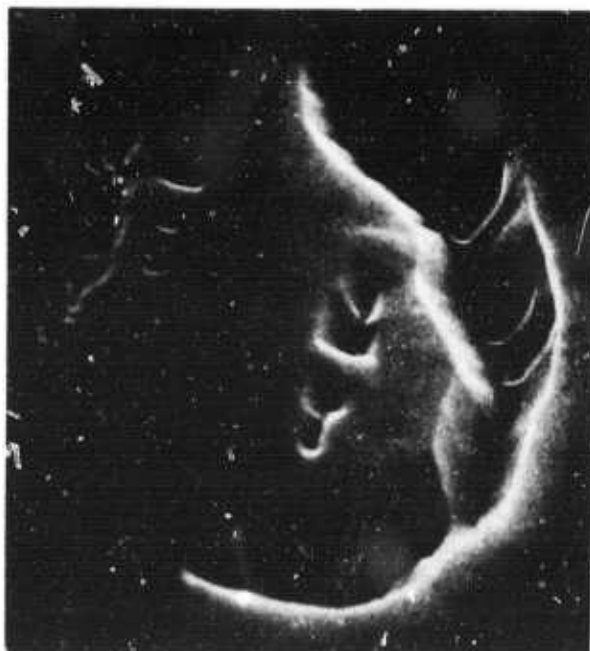
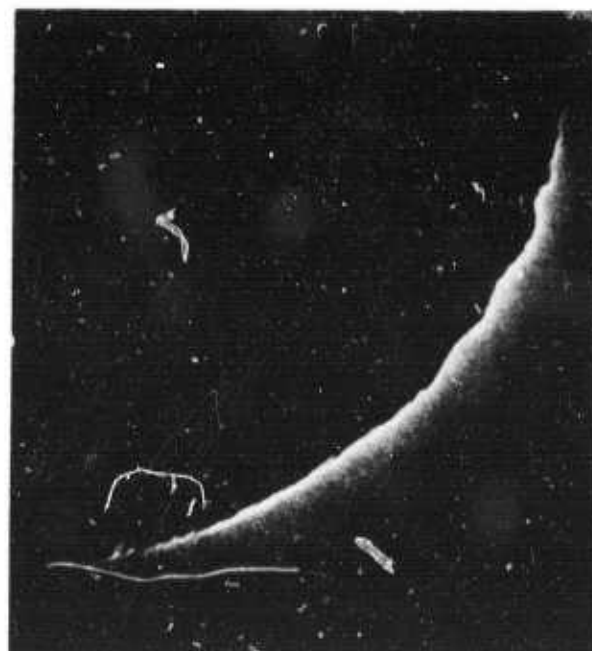
SEM micrograph of fracture cone.
(Left) After cupric ion polish.
(Right) After silicon dioxide polish.

A SEM study illustrates and corroborates the results obtained above. The strong etching effects of the cupric ion solution are shown in Figs. 12a and 12b. Figures 13a and 13b are SEM micrographs of a silicon dioxide repolished sample (10 and 15 μ m). In these pictures no deepening of the crack and no walls with sharp edges are seen.

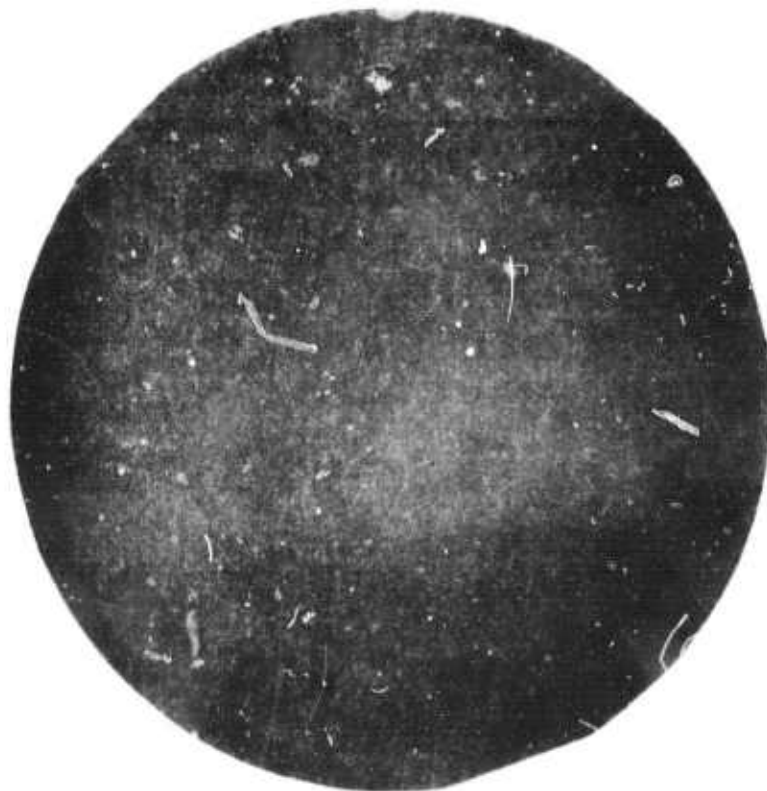
Fig. 1a. X-ray topographs of water before ISS.

Examples of ISS wafers are shown in the x-ray topographs of Fig. 1. The topograph shown in Fig. 1a is before stressing and reveals the high quality (zero dislocation) of the substrate used. Figures 1b through 1d are topographs of ISS silicon wafers stressed at 12 watts, 40 watts and 60 watts respectively. The black contrast in the topographs reveals the damage distribution in the wafers. Note that the damage is not uniform across the wafer surface but is localized in certain areas. With rising power the damage distribution

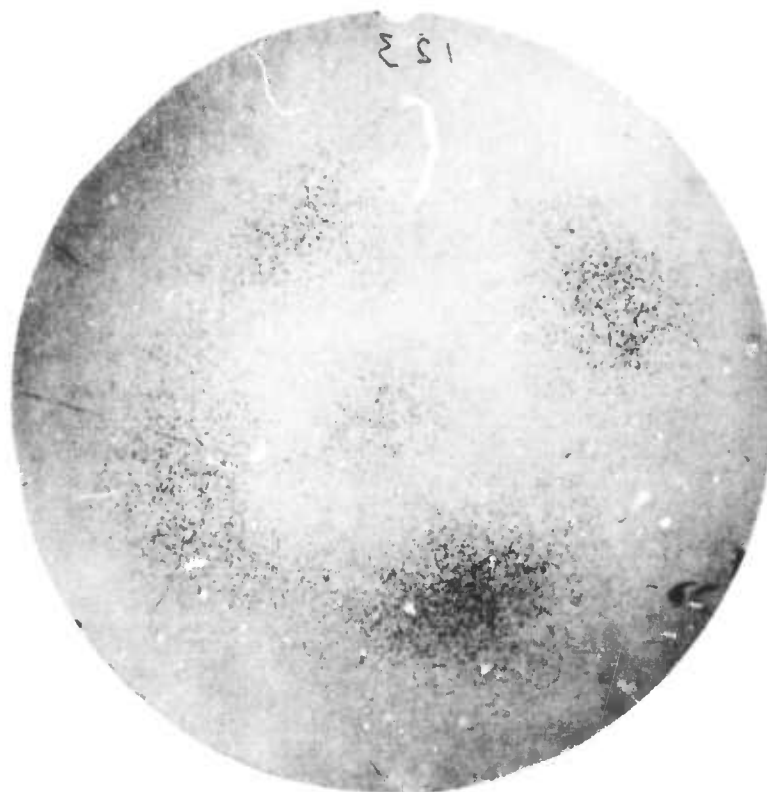
Fig. 1b. X-ray topograph of ISS stressed:
12 watt.

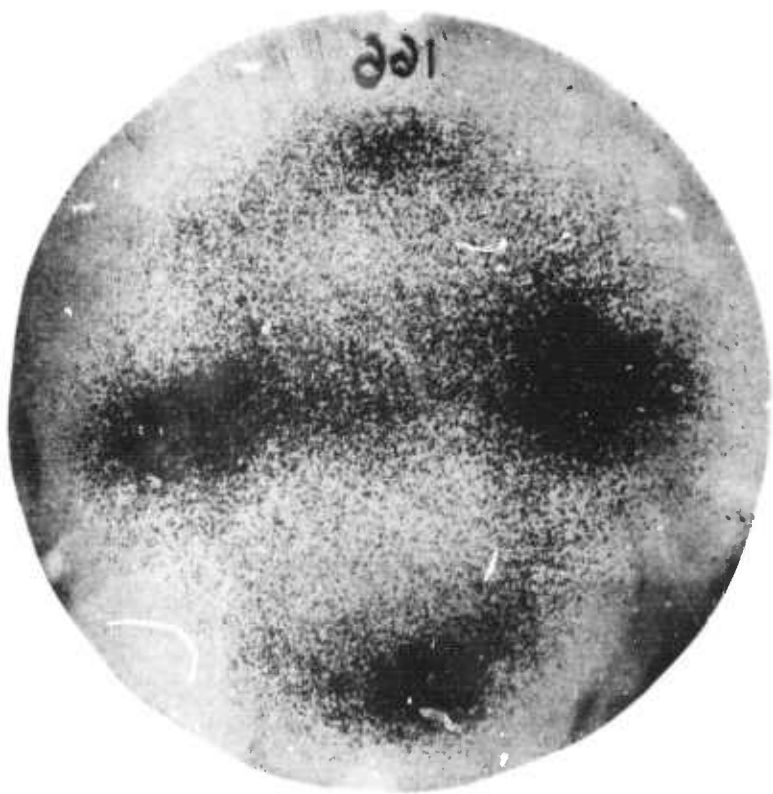
Fig. 1c. X-ray topograph of ISS stressed:
40 watt.

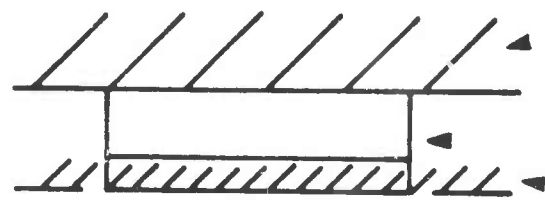
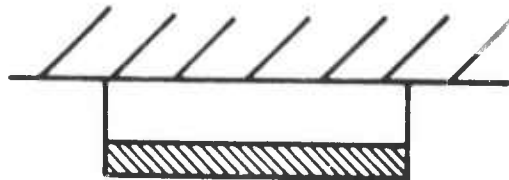
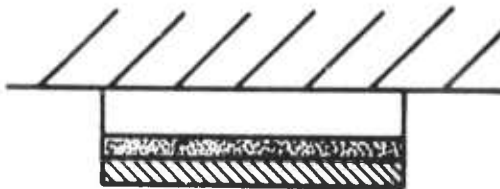
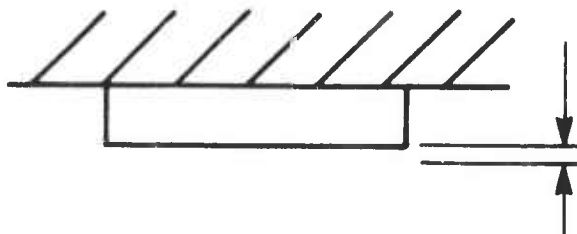
Fig. 2. Cupric ion process.

Mounting Plate

Silicon Wafer

Polishing Cloth and Slurry

Cu Plates onto Silicon

Silicon is Oxidized

Copper is Wiped From the Silicon by the "Wiping" Action of the Polishing Cloth

Oxide Dissolves by the Action of the Fluoride Constituent of Slurry

These steps in the polishing process are schematically shown in Fig. 2. The chemical reactions may be written as:

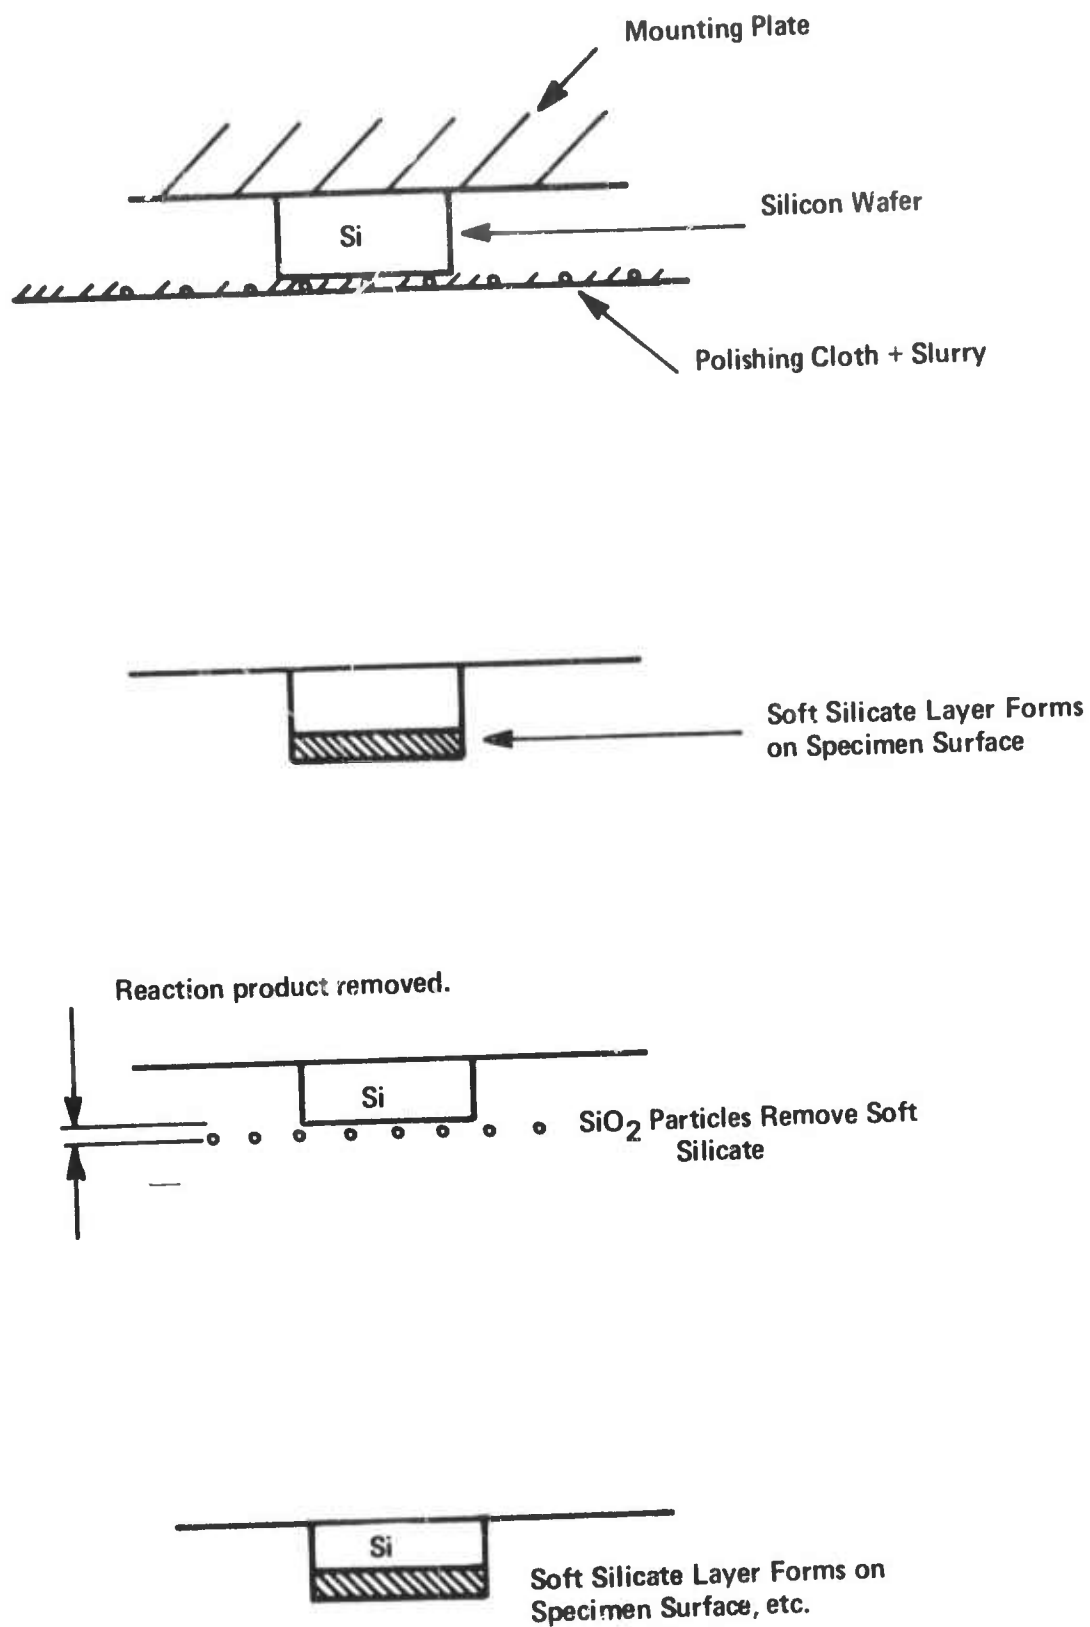
Fig. 3. Silicon dioxide process.

The primary silicon surface, in turn, is harder than the SiO_2 abrasive particles, and it remains unaffected. These steps in the process are illustrated schematically in Fig. 3.

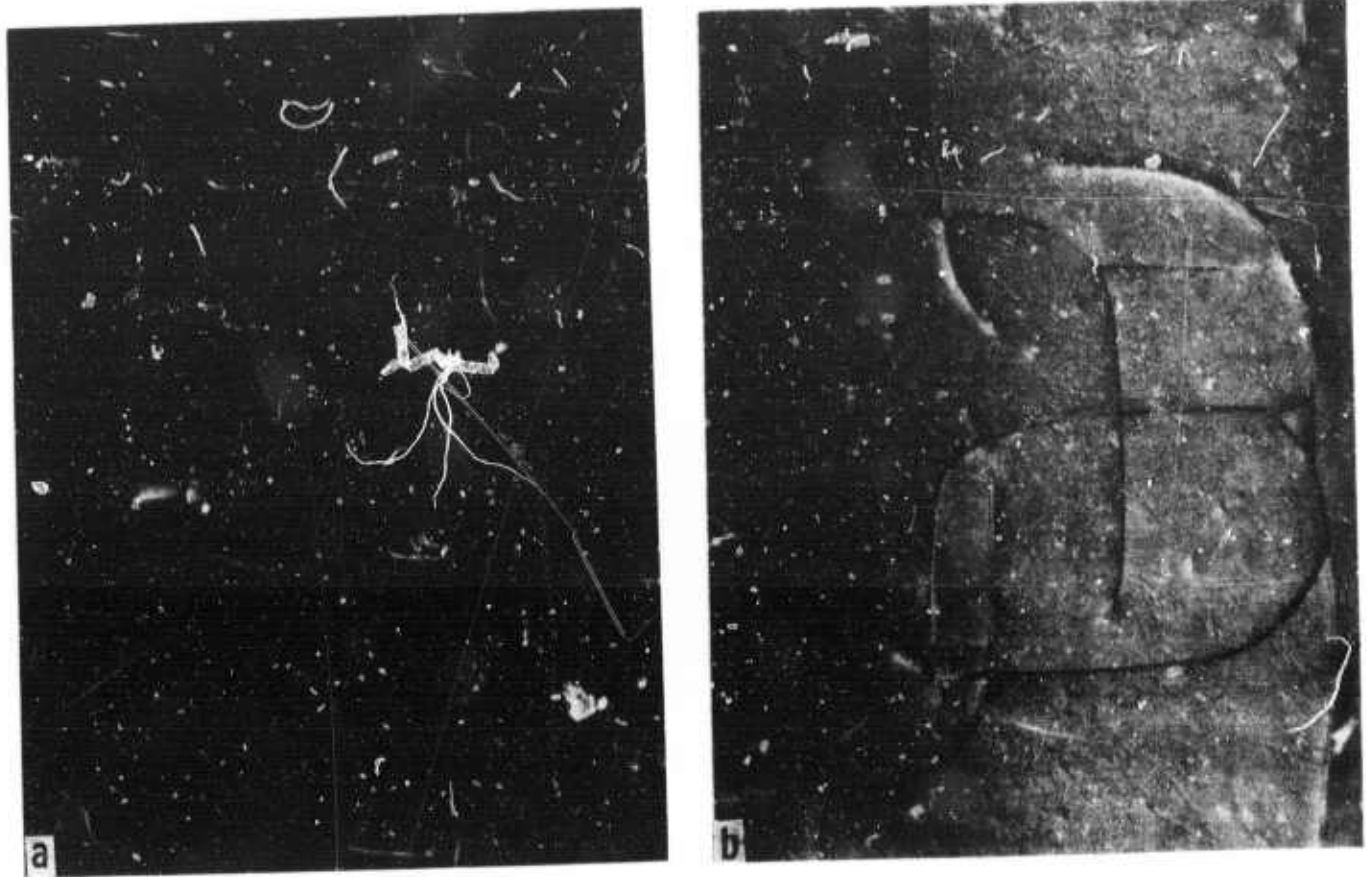
Fig. 4. Impact sound stressed (ISS) silicon, (001) surface, showing Hertzian fracture cones.

a. As stressed (320X).

b. As stressed, 10 seconds Sirtl etched (855X).

Fracture cones on (001) surfaces are shown in Figs. 4. In Fig. 4a the surface is shown directly after ISS while the surface shown in Fig. 4b has been Sirtl etched for ten seconds after ISS to show the fracture cones more clearly. The direction of the long arms of the cracks is $\langle 110 \rangle$. The depth of the cracks was determined by two different methods. The first technique evaluates the crack depth with the help of a one and a two degree bevel. This is shown in Figs. 5. The damage depth profile introduced by sound stressing is clearly visible on the bevel. The damage depth calculated from the damage profile ranges from 15 μ m to 20 μ m and is indicated on the photomicrographs. The second technique uses cross sections of cracks produced by cleavage for depth evaluation. After cleavage the samples are a seconds Sirtl etched to show the cracks more clearly. An example is given in Figs. 6. Figure 6a shows the surface of the sample and Fig. 6b the cross section. The corresponding parts of one crack on the two photos are indicated by an arrow.

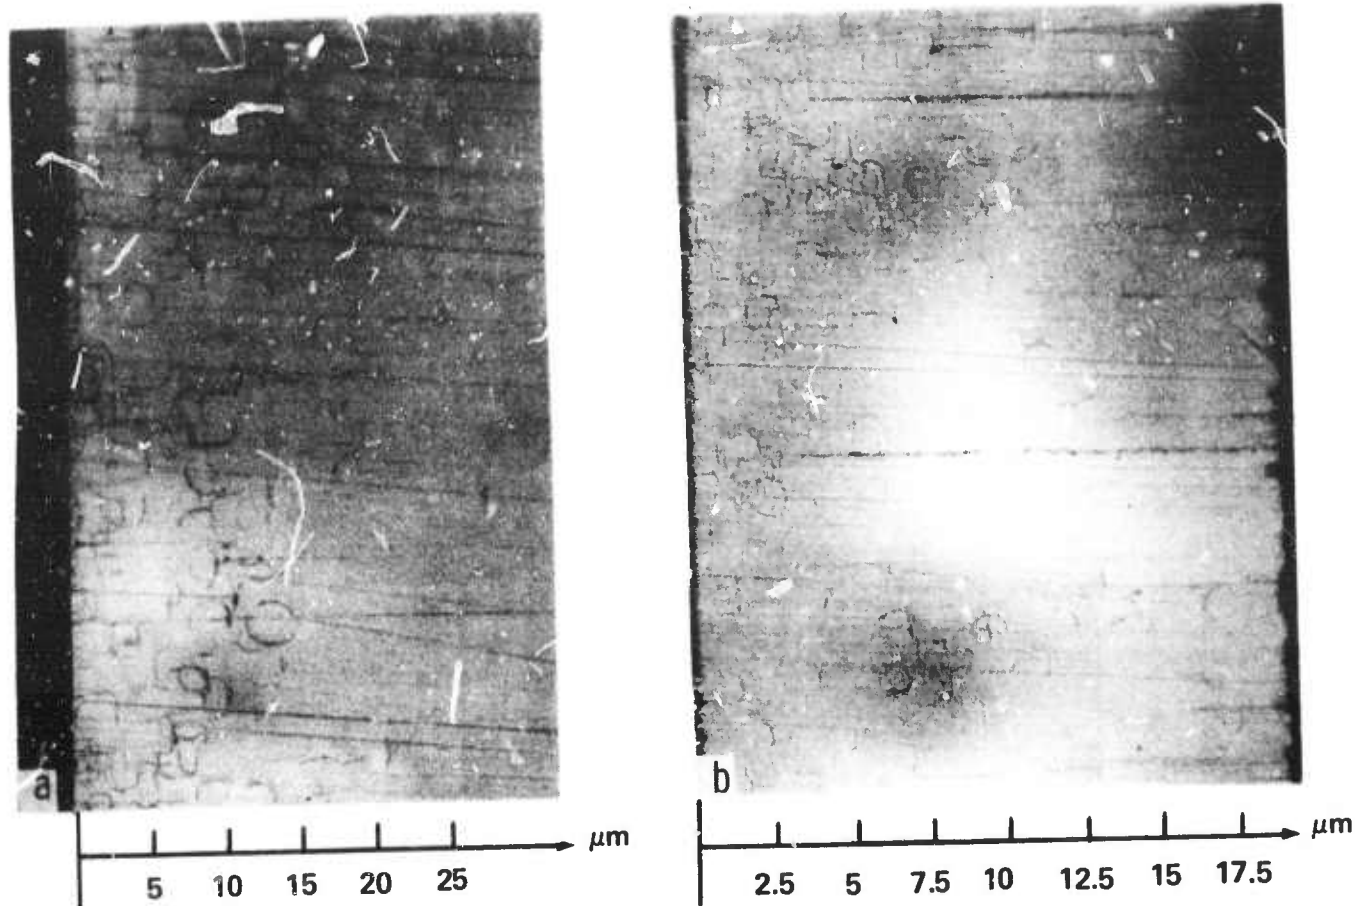
Fig. 5. Damage profile of ISS silicon displayed by the bevel technique.

- a. 2 degree bevel (67X).
- b. 1 degree bevel (67X).

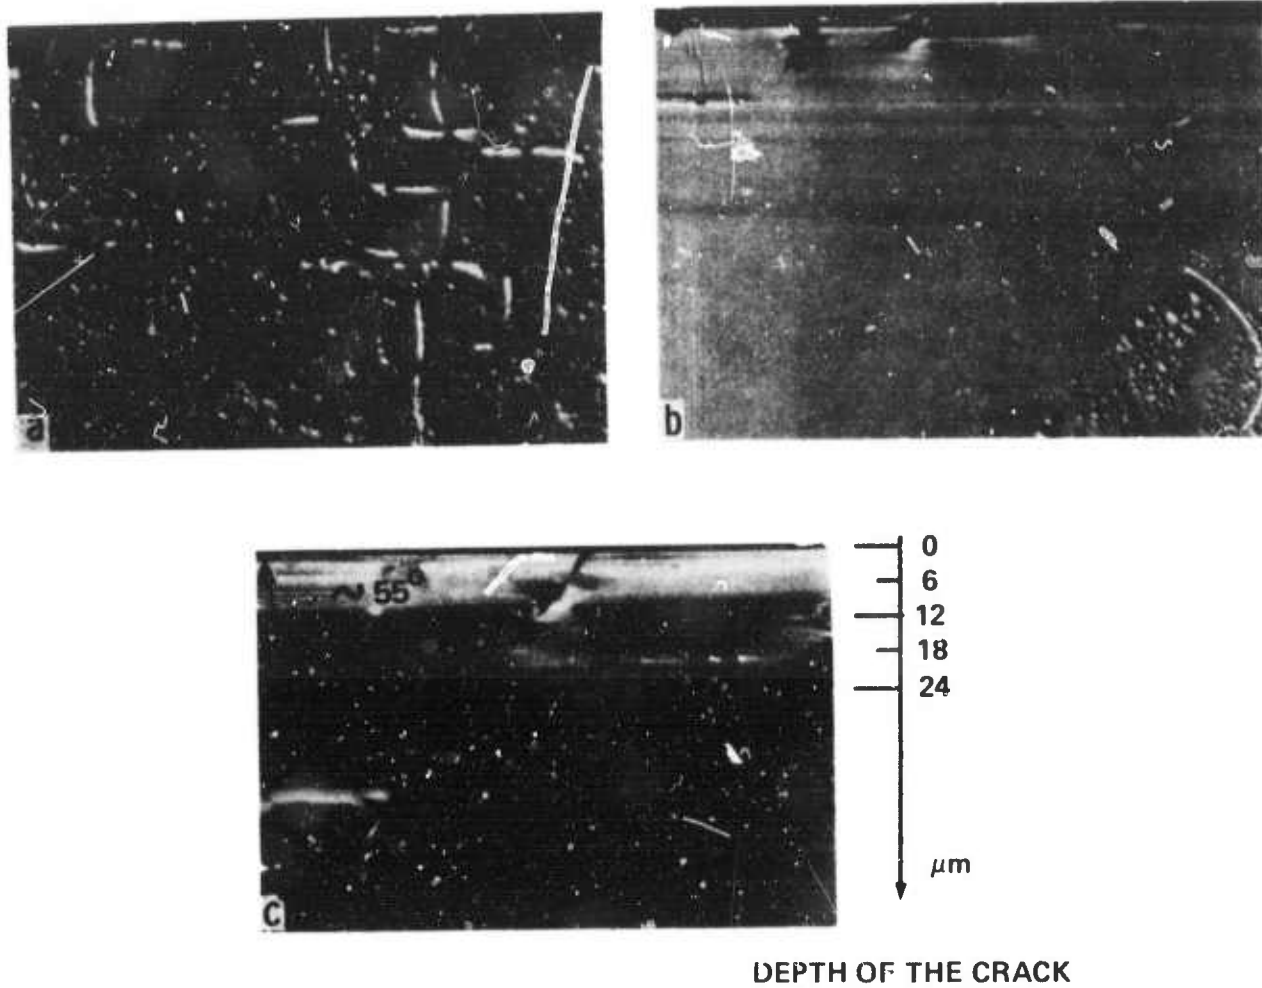
Fig. 6. Damage profile of ISS silicon displayed by the cleavage technique.

- a. Surface (320X).
- b. Cleavage plane (320X).
- c. Note propagation of fracture cone in (111) plane (855X).

The cross section is shown magnified in Fig. 6c. It can be seen that the angle between the wafer surface and the crack is 55 degrees. This is very close to the interplanar angle between the (100) and (111) planes which is 54.8 degrees. The depth of the crack can also be measured on such cross sections. For this crack the depth is 18 μ m, which is in good agreement with the values found by the beveling technique.

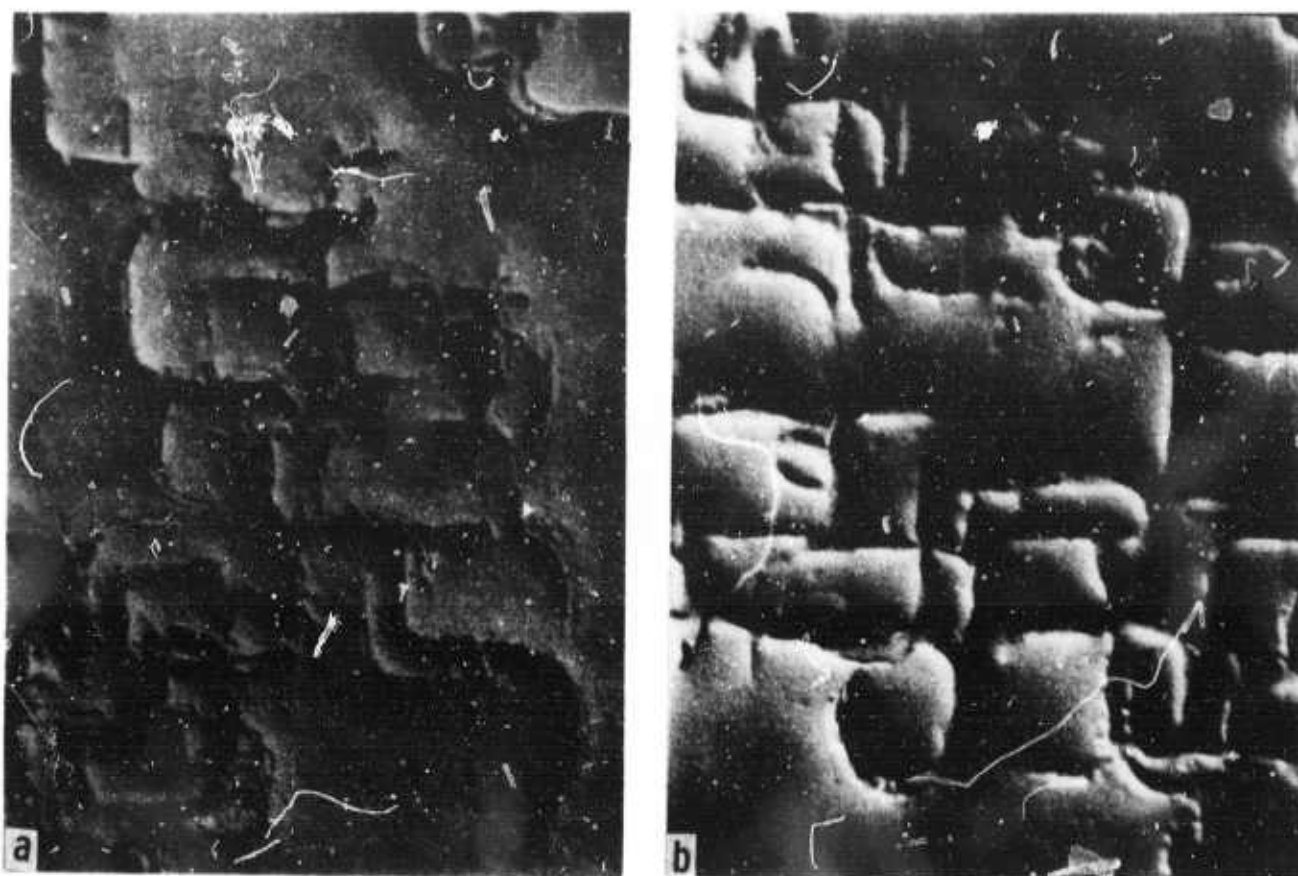
Fig. 7. Damage removal with 3/2/1 etch. Wafer backside not protected (320X).

- a. 25 μm removed.
- b. 50 μm removed.

The acid mixture $3\text{HNO}_3 - 2\text{CH}_3\text{COOH} - 1\text{HF}$ produces a fast etching effect on both sides of the wafer. Since only the front side is mechanically damaged the etch rate is not necessarily equal on both sides. It is assumed that the etch rate initially is more rapid on the front side. An average etch rate of 25 μ m/minute was registered during the two first minutes. The micrographs of Figs. 7(a,b,c,d) illustrate four steps of the fast acid attack: this fast acid tends to smooth the silicon surface. After removal of 115 μ m on both sides, or at most 65 μ m on the front side, this surface appears damage free.

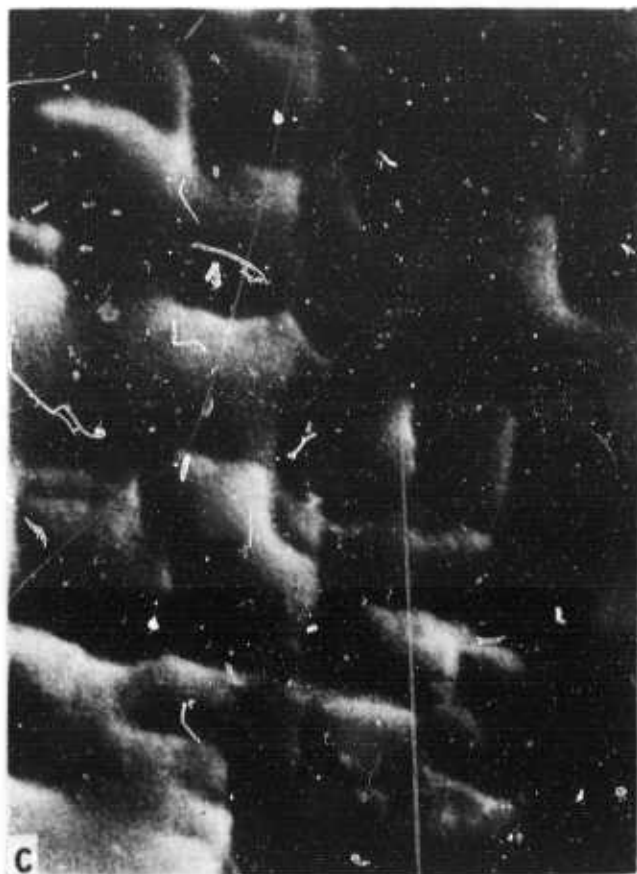
Fig. 7. Damage removal with 3/2/1 etch. Wafer backside not protected (320X).

- c. 85 μm removed.
- d. 115 μm removed.

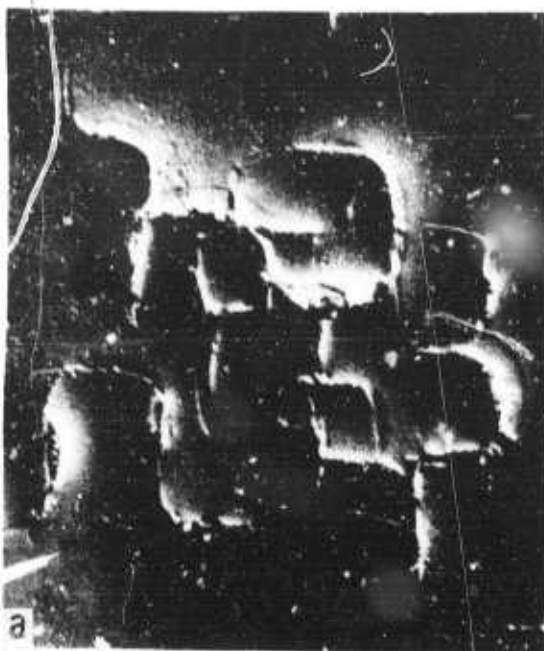
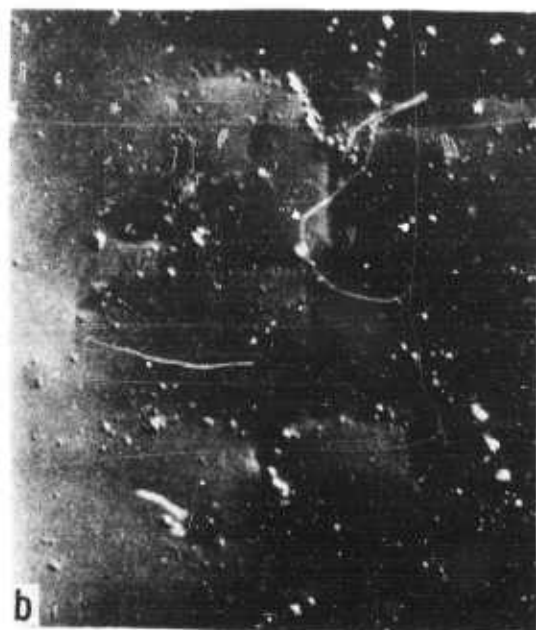
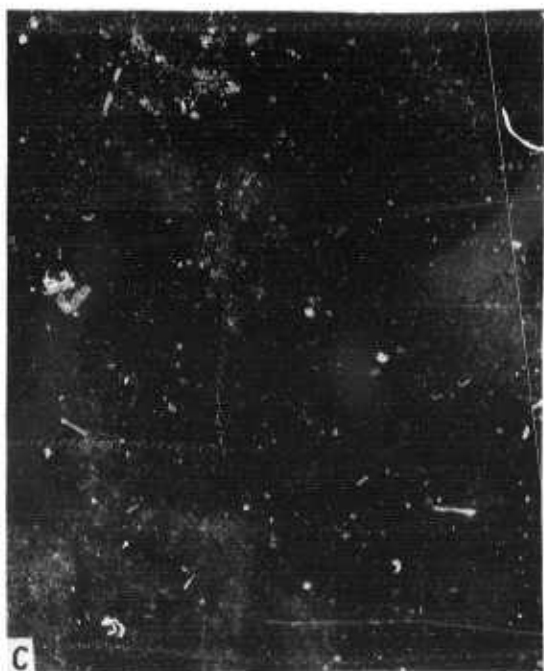
Fig. 8. Damage removed with 3/2/1 etch. Wafer backside protected with black wax, 320X.

- a. 16 μm removed.
- b. 36 μm removed.
- c. 70 μm removed.

Protecting the wafer backside drops the etch rate to approximately $5.5\mu\text{m}/\text{min}$. The results are presented in Table I and typical micrographs are displayed in Figs. 8(a,b,c). Note that 60 to $70\mu\text{m}$ must be removed to eliminate the fracture cones.

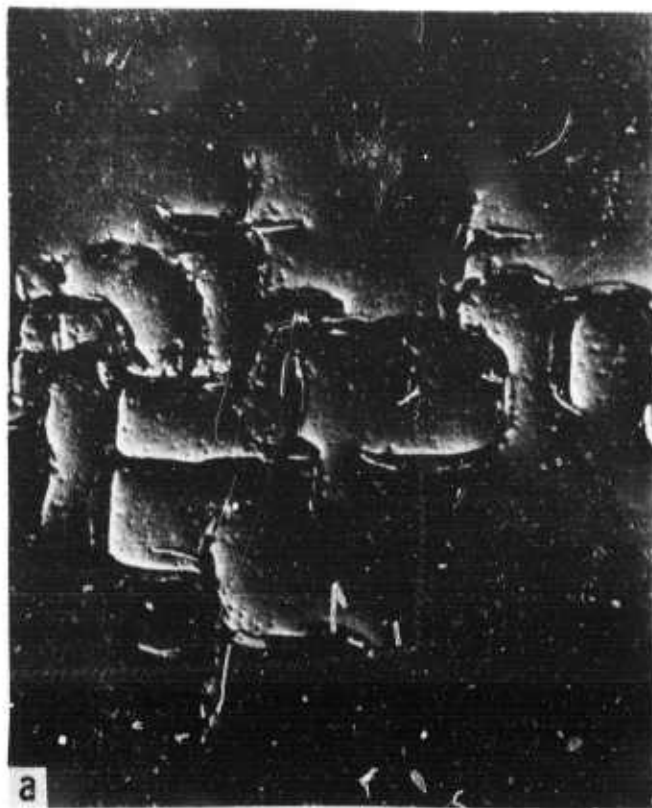
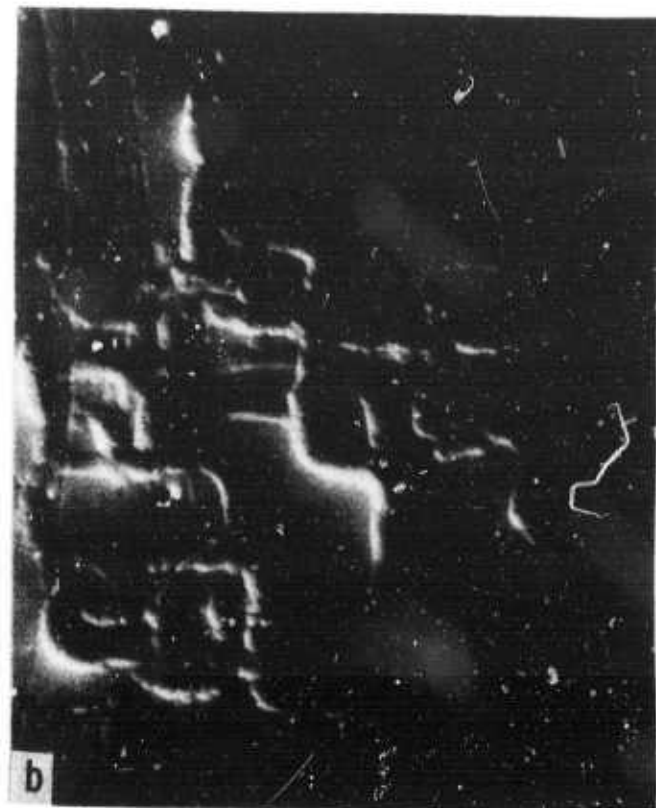
Fig. 9. Damage removal with slow etch. Wafer backside protected (320X).

- a. 5 μm removed.
- b. 70 μm removed.

Damage removal using an acid of composition 30 parts HNO_3 - 1 part HF provides a relatively slow etching action on silicon. The etch rate for this solution is $1.4 \pm 0.2 \mu\text{m}/\text{minute}$ for backside protected wafers. Typical etching steps are shown in Figs. 9(a,b,c,d). Interesting characteristics concerning the etching behavior are noticed:

- the slow acid leaves sharper edges delineating the cracks (Fig. 9a).
- the cracks stay visible longer and are well defined (Fig. 9b). When the etching progresses, the cracks look like worms. The surrounding areas are much less affected than with the fast acid. Therefore,
- the slow etching action can be qualified as more preferential than the fast acid attack.
- approximately $90 \mu\text{m}$ must be removed to eliminate the surface damage.

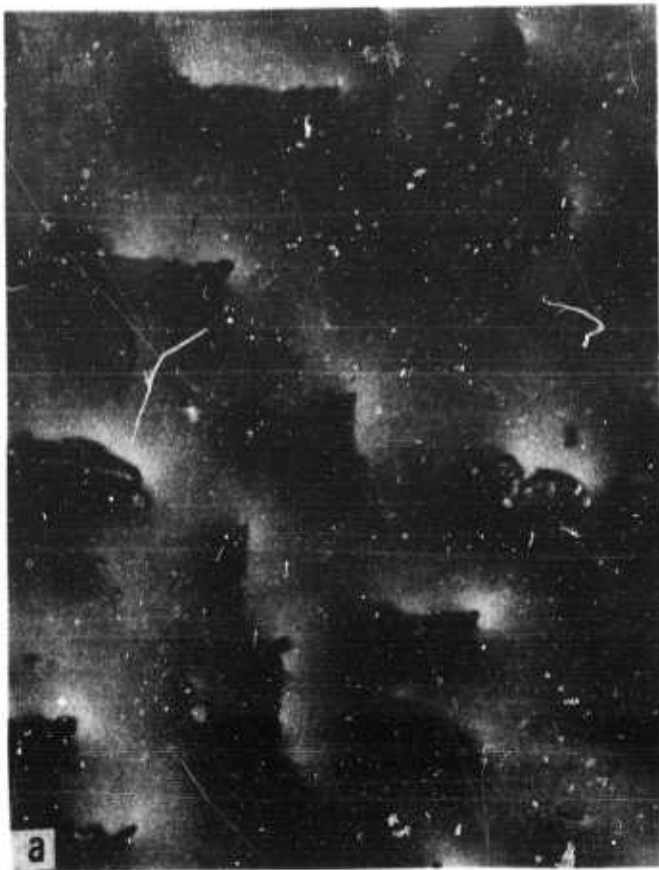
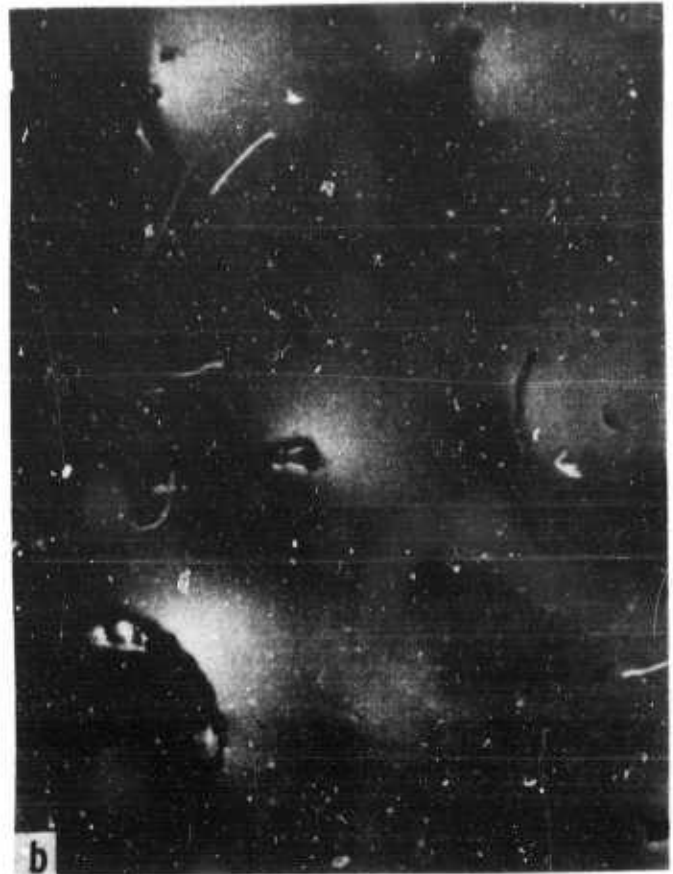
Fig. 10. Damage removal with cupric ion polish (320X).

a. 10-15 μm

b. 15-20 μm

The action of the cupric ion polish^{*} during damage removal is shown in the photomicrographs of Figs. 10. After the first repolishing step of about 10-15 μ m, an "opening" of the cracks is observed. The surface around the cracks becomes lightly wavy; the abrasion spots, however, have almost completely disappeared. This is shown in Fig. 10a. In Fig. 10b, 20 μ m have been removed. The density of the remaining defects has decreased but the more intense cracks are now wider and bigger than before. This is also shown in Fig. 10c, where a heavily stressed sample has been repolished to about 25 μ m. 30 μ m have been removed in the sample shown in Fig. 10d. A few defects are still left which coincide mainly with the central part of the fractures. Fig. 10e shows the last step in the repolishing process of this type of defect before a perfect looking surface is obtained again. At least 40 μ m to 50 μ m have to be removed by copper polishing to reproduce a perfect surface.

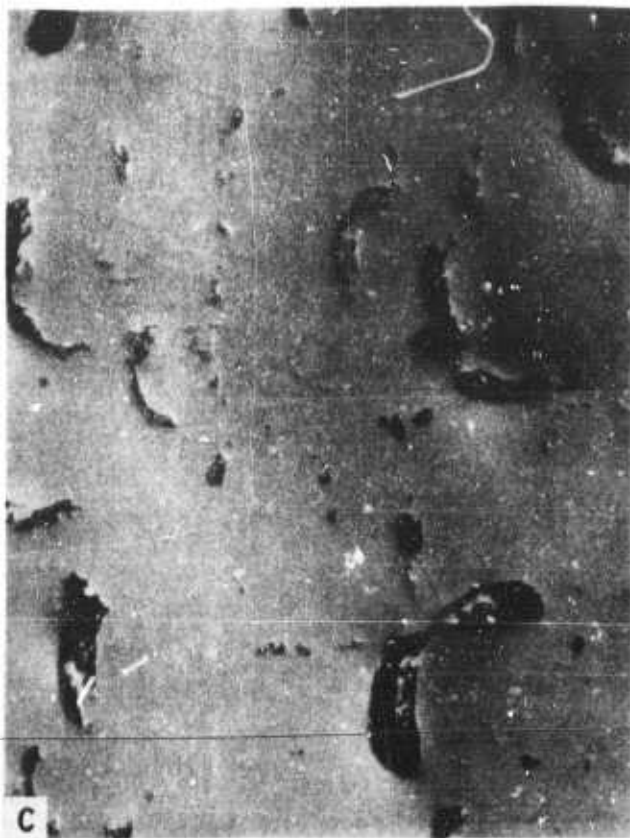
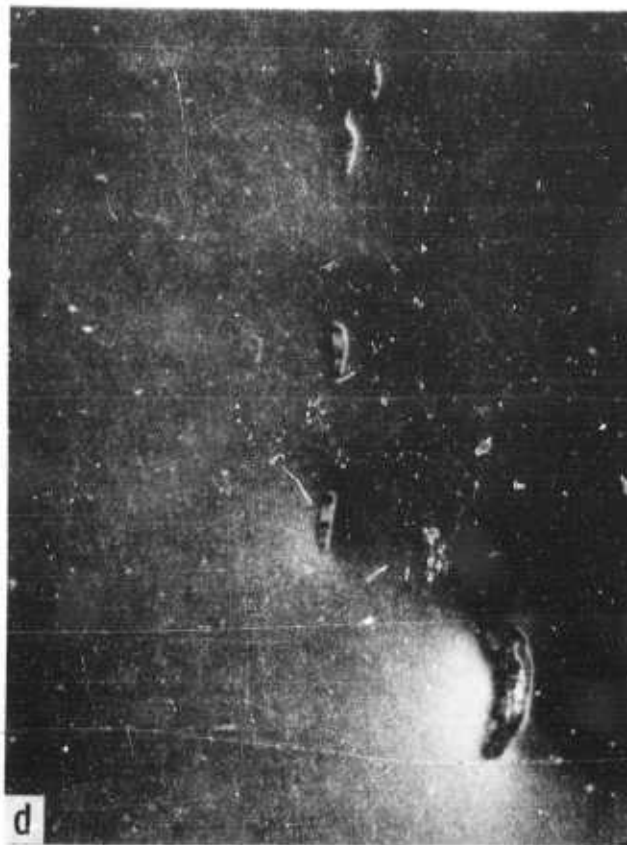
Fig. 10. Damage removal with cupric ion polish (320X).

c. 20-25 μm

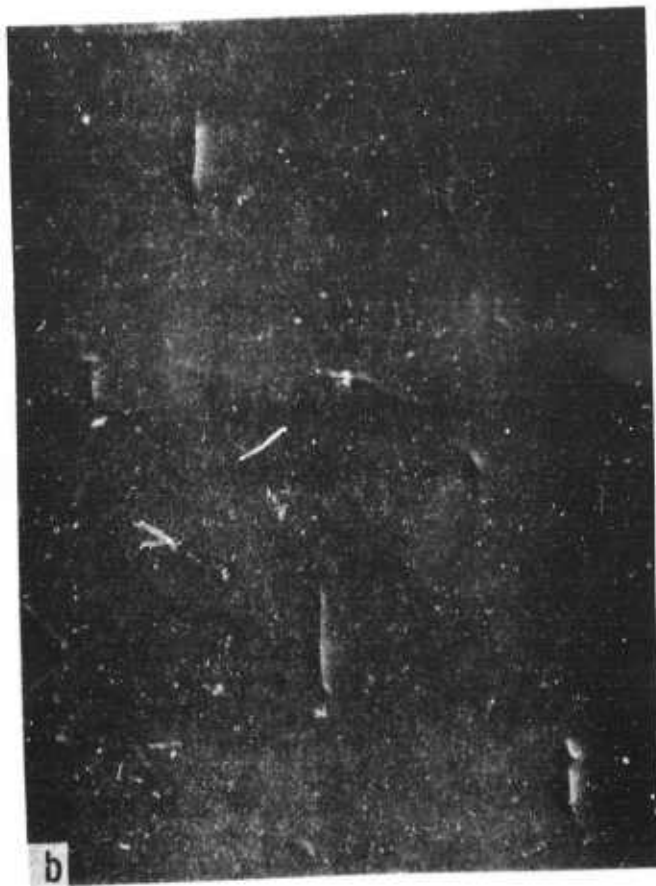
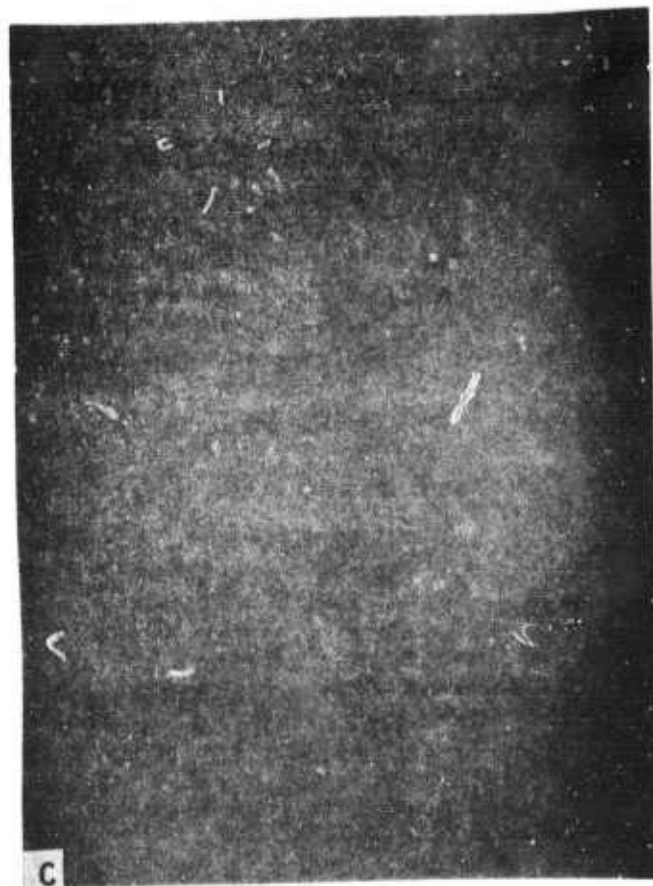
Fig. 11. Damage removal with silicon dioxide polish (320X).

- a. 10 μm removed.
- b. 15 μm removed.
- c. 20 μm removed.

Similar measurements were made using silicon dioxide to repolish the samples. There is one important difference between this technique and the chemical and the cupric ion polishing techniques. Silicon dioxide polish rapidly decreases the density and the size of the cracks in the repolished surfaces. This is shown in the photo-micrographs given in Figs. 11. Figure 11a is obtained after the 10 μ m step. It can be seen that this time the narrow fracture lines show no opening. The abrasion spots have totally disappeared. Figure 11b shows that after 15 μ m, the crack density and the length of the fracture lines have sharply decreased. The surface in between already looks perfect. As shown in Fig. 10c, only a few very small defects can be detected after removing 20 μ m, whereas the surface is always perfect after removal of 25 μ m. Thus silicon dioxide does not propagate the damage. Consequently, only a few microns more than the damage depth has to be removed to obtain a perfect surface. The silicon dioxide polish regenerates the surface perfection most efficiently and most completely.

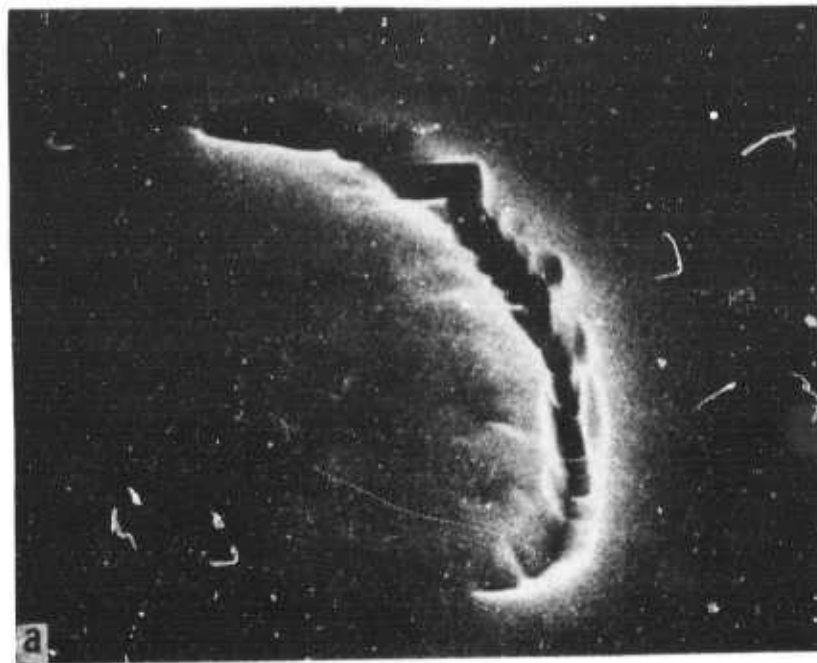
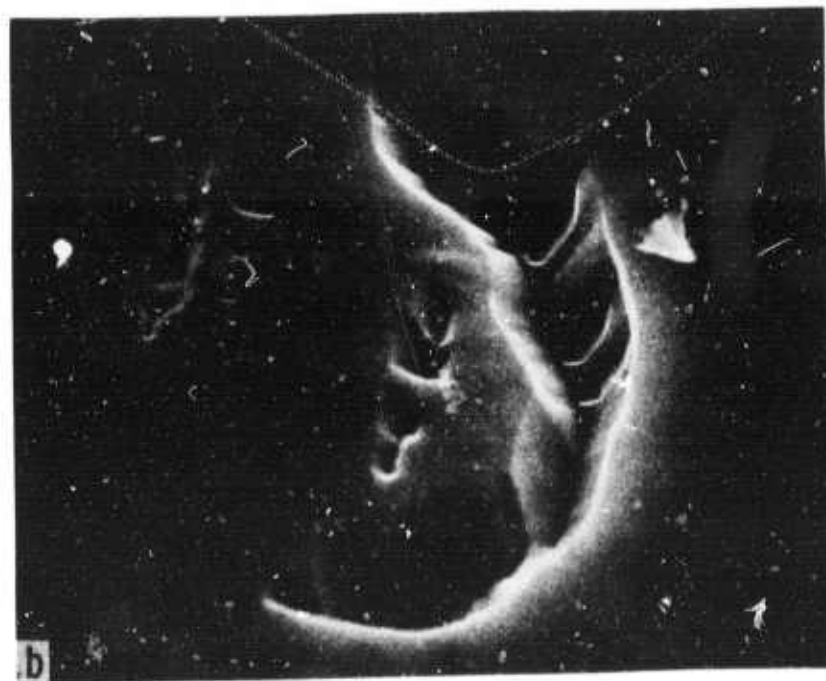
Fig. 12. SEM micrograph of fracture cone after cupric ion polish recorded at 30 kV, 45 degree view (1.8 KX).

- a. 10-20 μm removed.
- b. 25-35 μm removed.

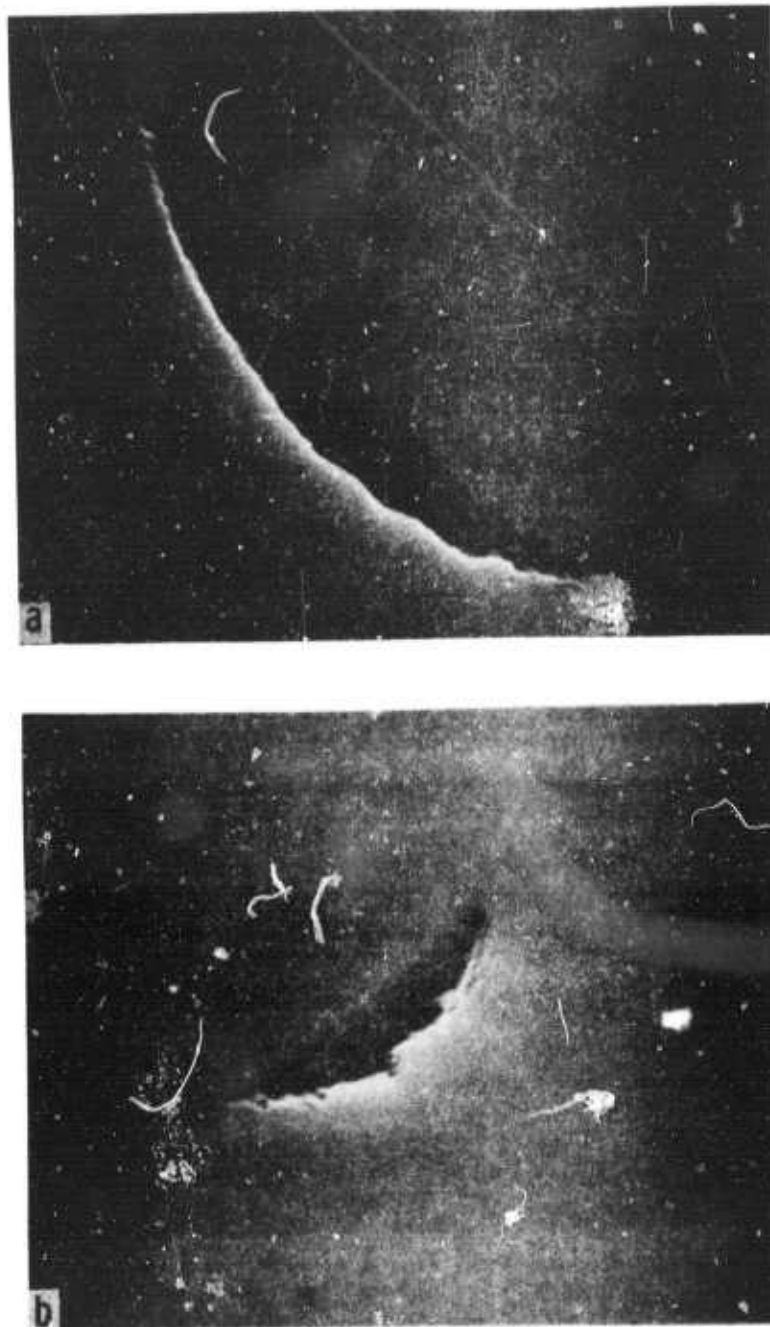
Fig. 13. SEM micrograph of fracture cone after silicon dioxide polish, recorded at 30 kV, 45 degree view (1.8 KX).

- a. 10 μm removed.
- b. 15 μm removed.

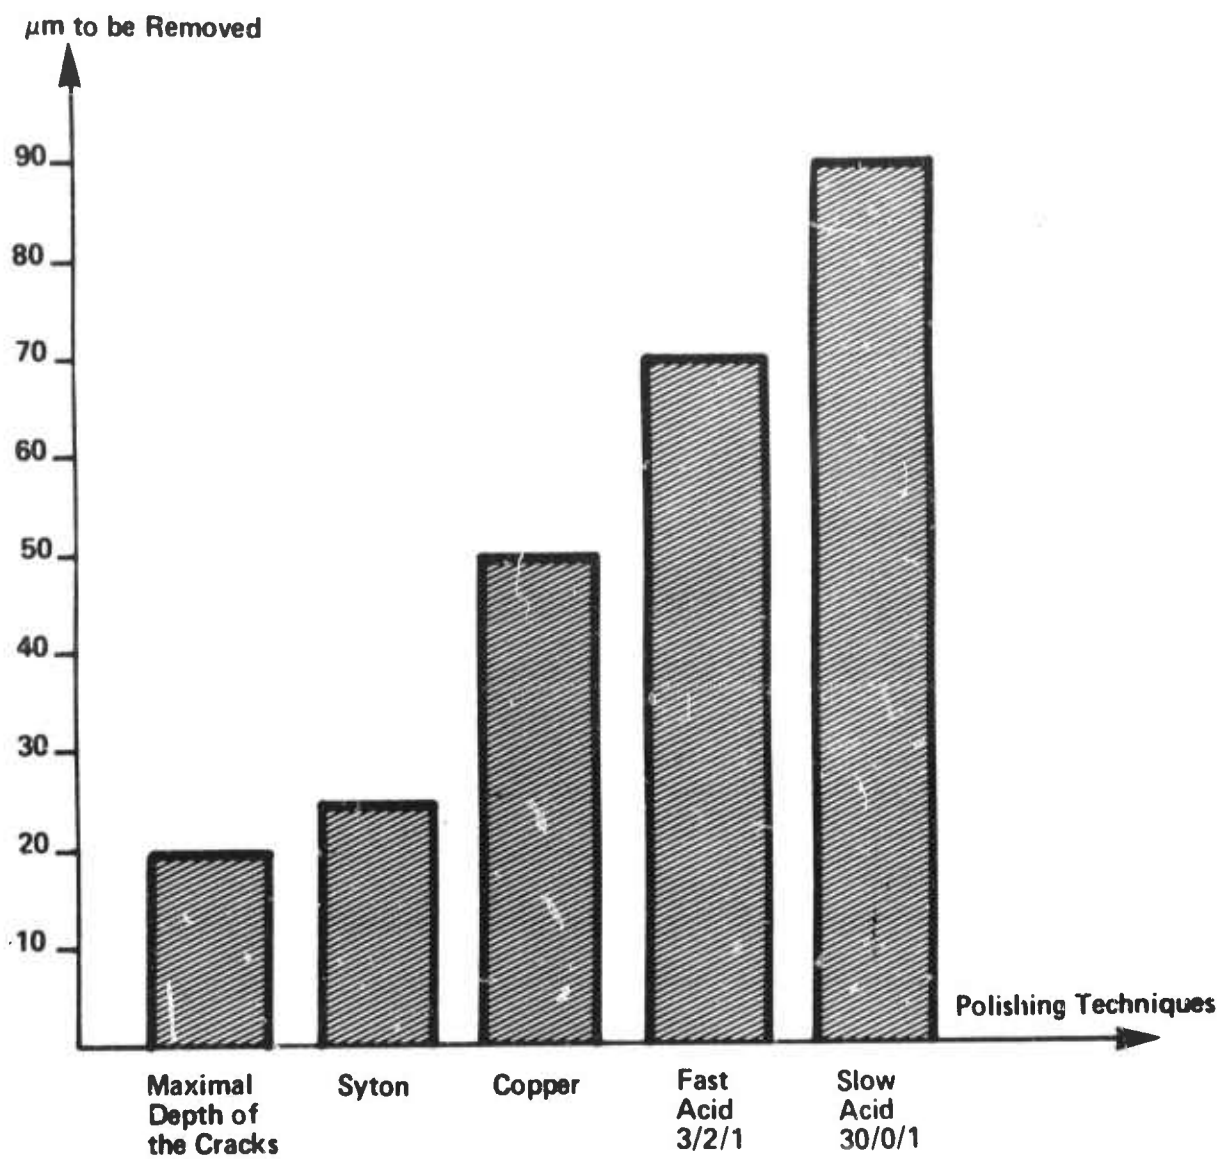
Fig. 14. Comparison of polishing techniques (damage depth $20\ \mu\text{m}$).

This is in complete agreement with our experimental findings that relate to the effectiveness of damage removal of polishing agents. Such data are summarized in Fig. 14. It is evident that the more mechanical acting polishing technique - silicon-dioxide - is also the most effective one

for damage removal but the least effective one for crack propagation. This tendency reverses with the increasing chemical activity of the polishing media. The least effective polish is the slow chemical etch but this etch is very effective in crack propagation.
